Recent Developments in Close Range Photogrammetry (CRP) for Mining and Reclamation

Office of Surface Mining and Reclamation
Pittsburgh, PA

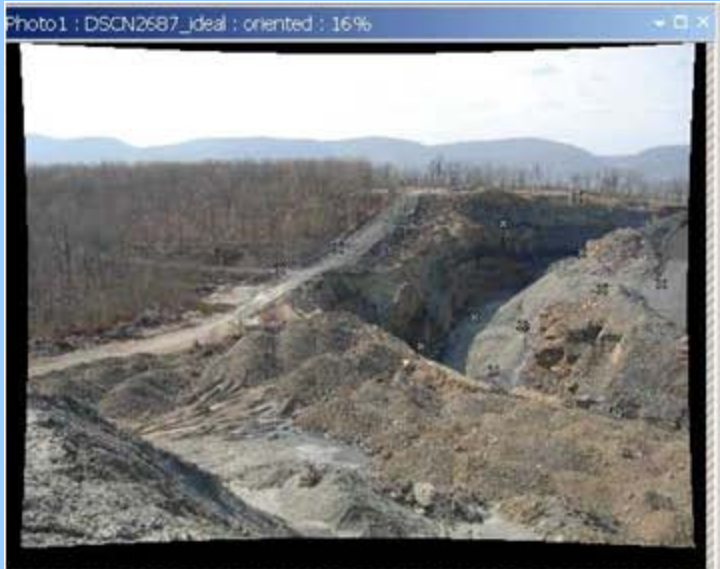
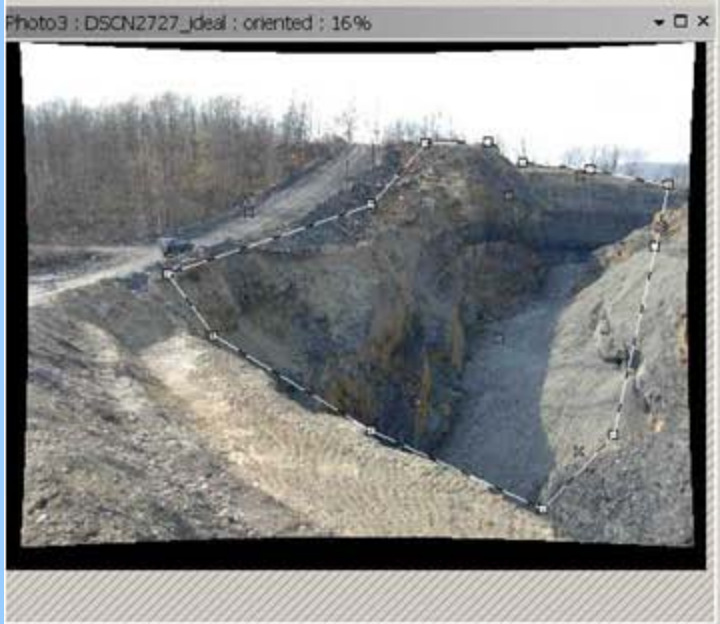
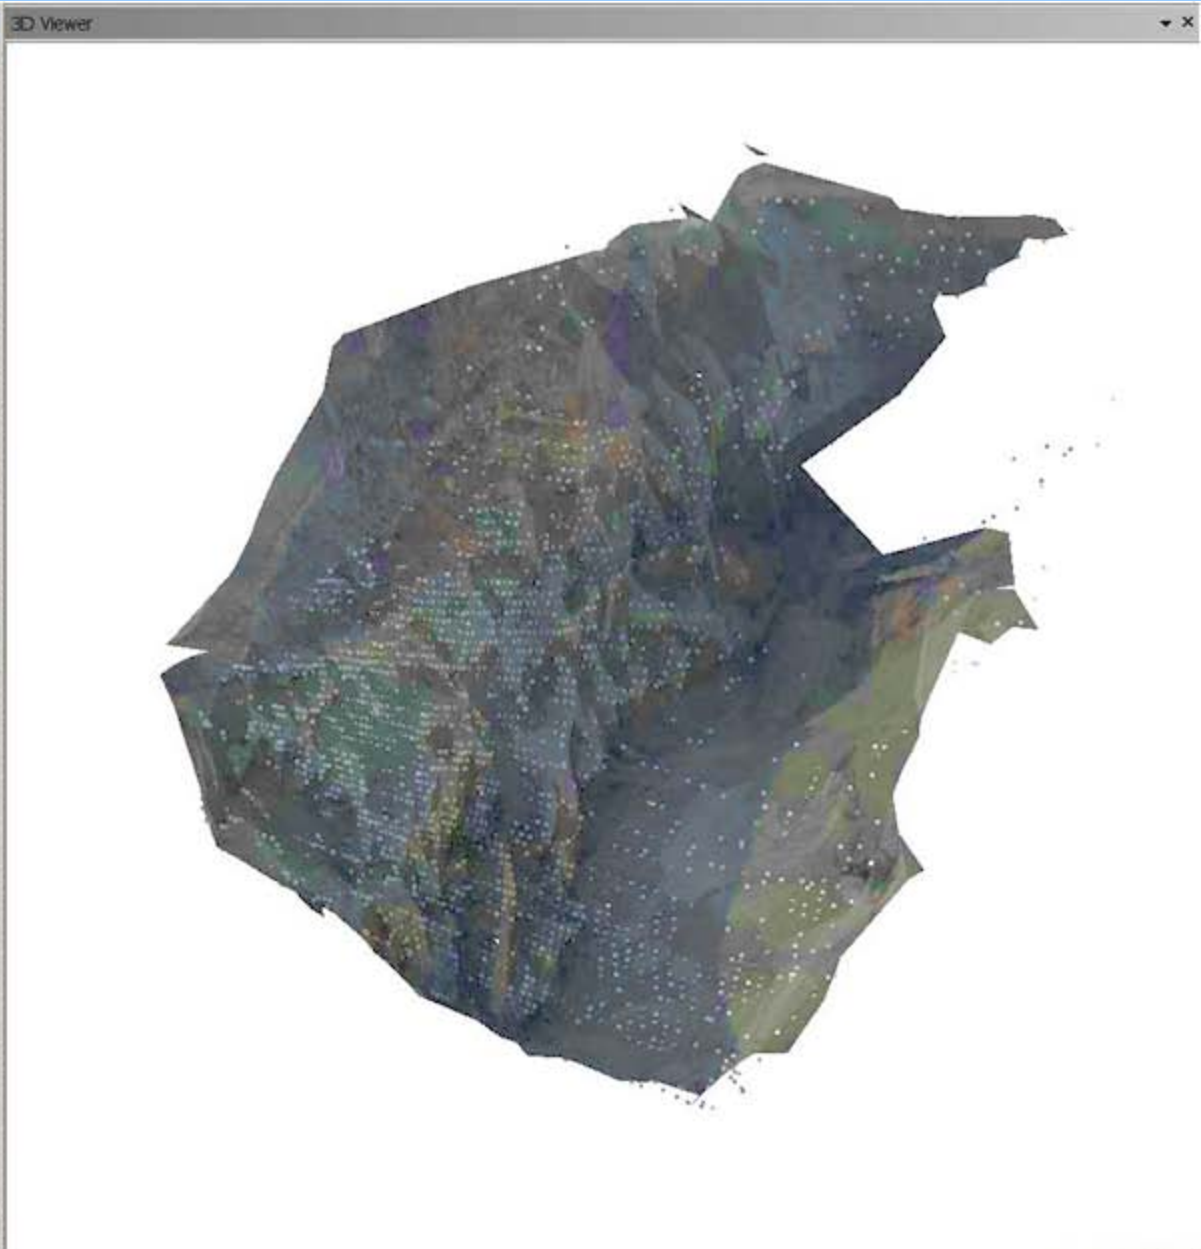
Unreferenced Trench Model

- The photos were taken with a camera that was later calibrated to remove lens and other distortions.
- The stereo coverage was not optimum yet the mesh was truly proportioned in XYZ.
- After scaling, rotation, and repositioning in CAD, the mesh matched closely to the aerial topography.

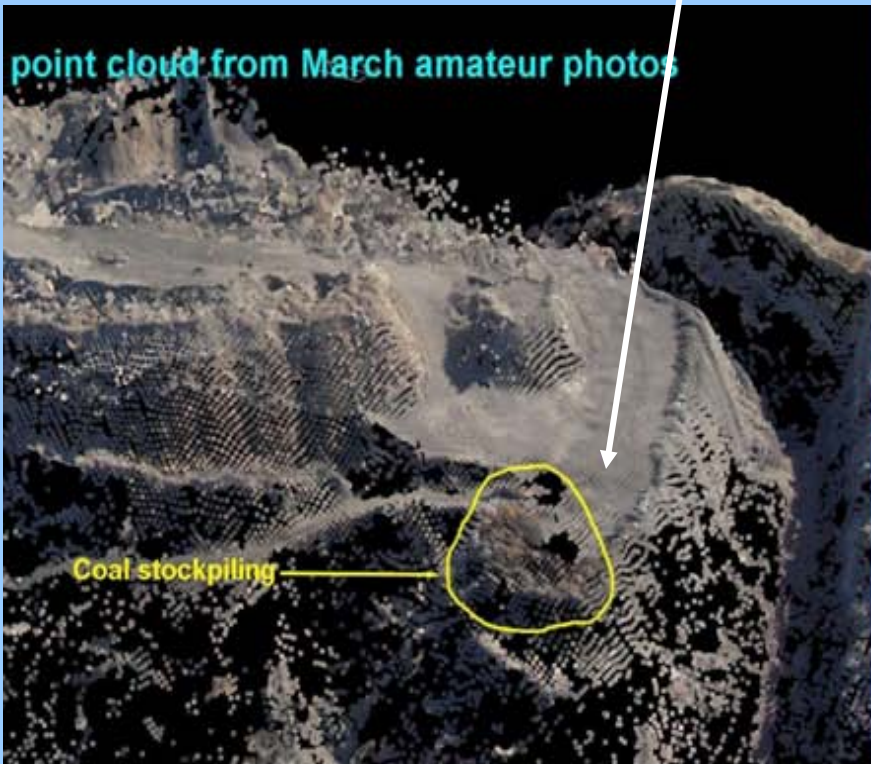
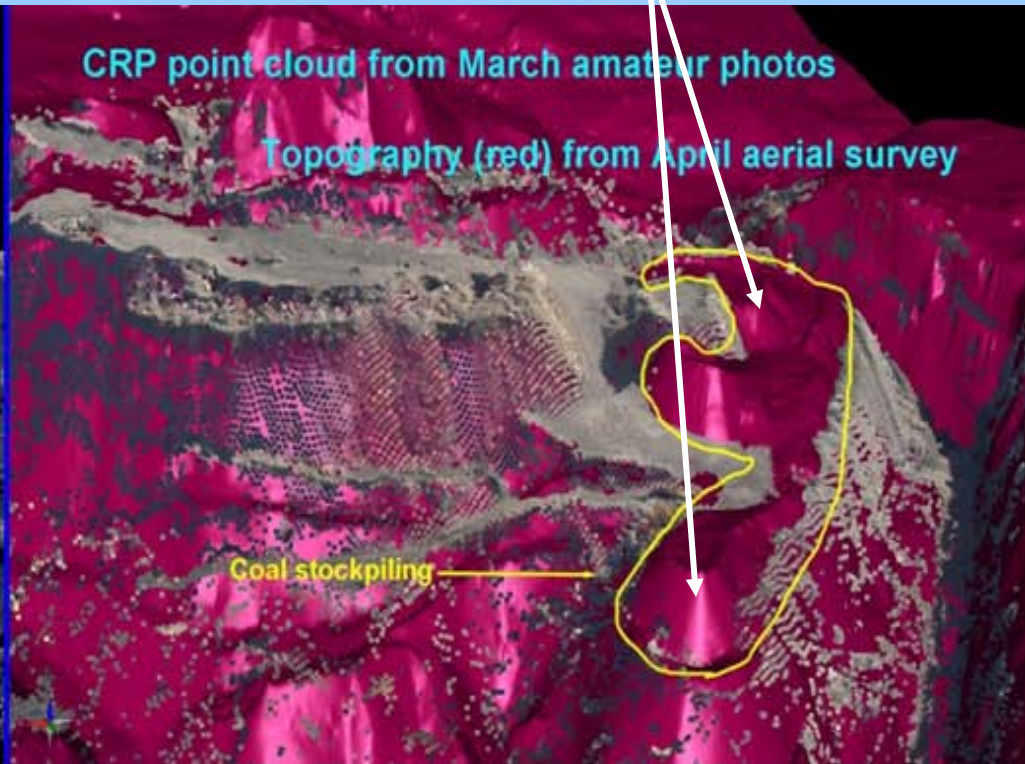
Referenced Stereo Model from Small Plane Photos (left); Overlain with Aerial Survey (right)

- The photos were taken with an unknown camera.
- Only ground control points were used to correct distortions and scale/reference stereo model.
- The stereo model is only accurate and stable near the model center (the stockpile pad); away from the center, the model is worthless.
- At center, model XYZ positions are within inches of the aerial survey.
- Stockpile volume estimates agree well with on-the-ground measurements.

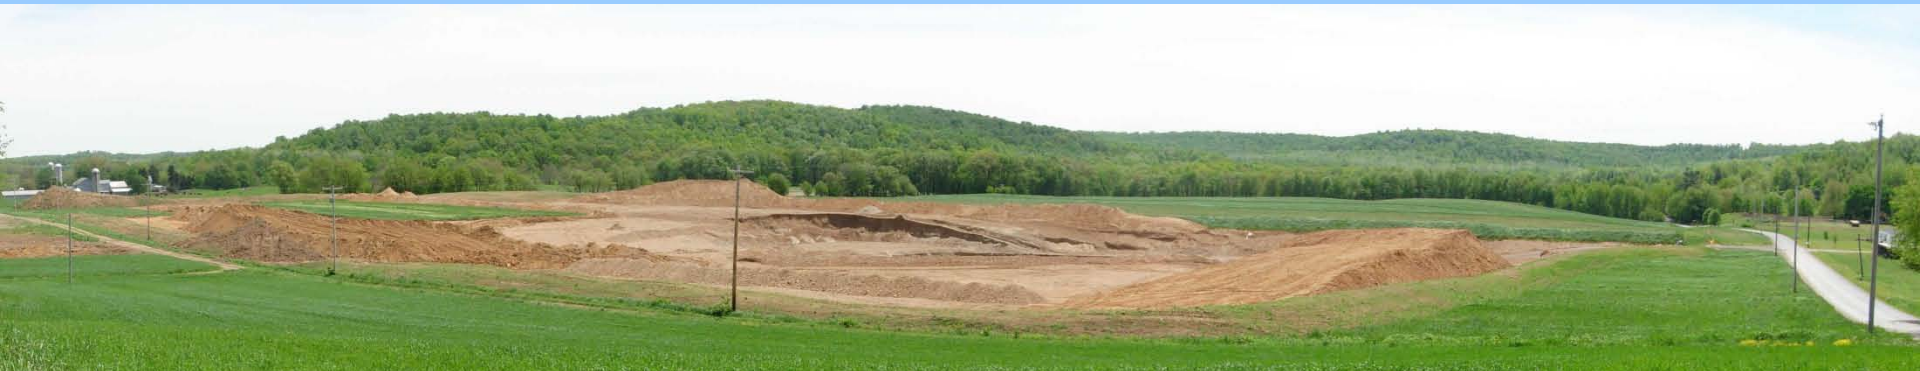
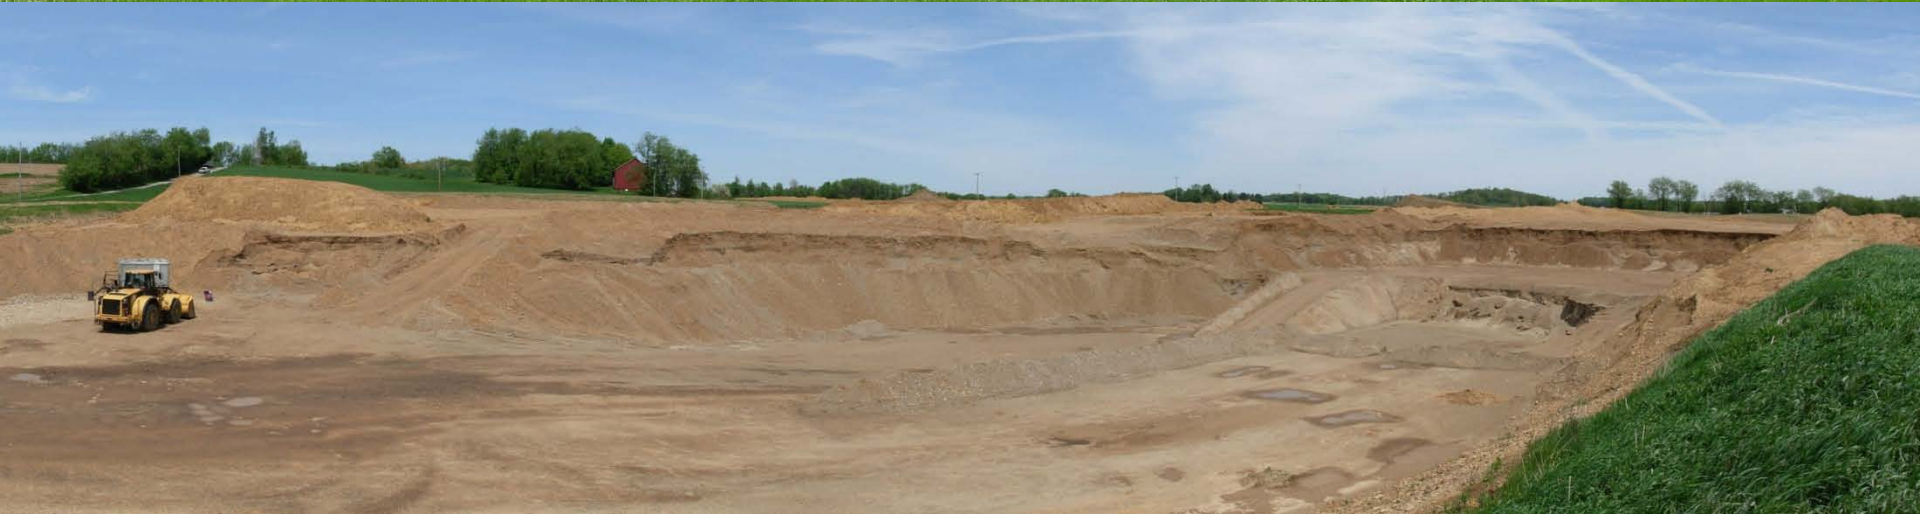
Sand and Gravel Pit, May 17, 2009

Disturbed Area ~ 400' by 1000'

- Extraction and segregation, topsoil stockpiling.
- Many features visible on 2006 digital imagery unchanged.
- Strong light, sun near nadir.
- Pit walls steep, near vertical.

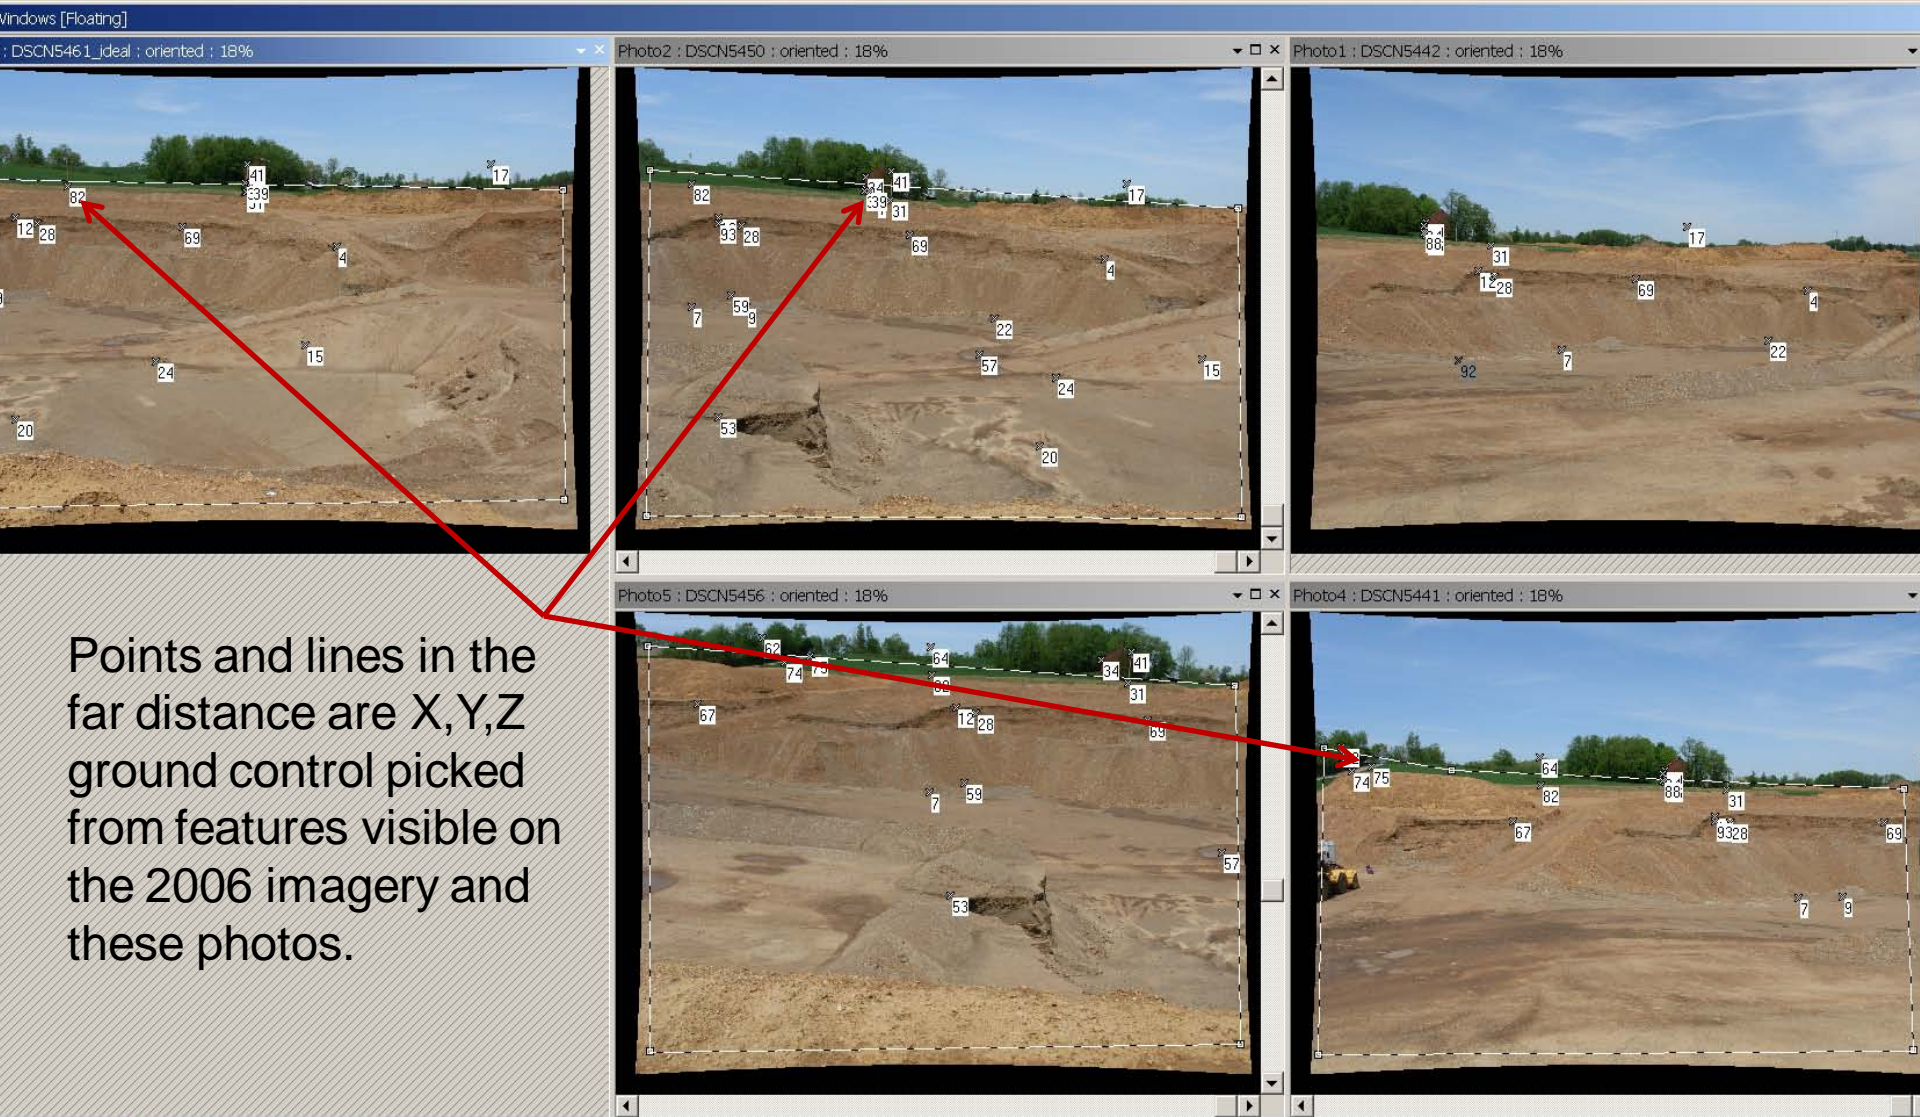
High Quality Photo Pairs with Points for Orientation and Ground Control

Points and lines in the far distance are X,Y,Z ground control picked from features visible on the 2006 imagery and these photos.

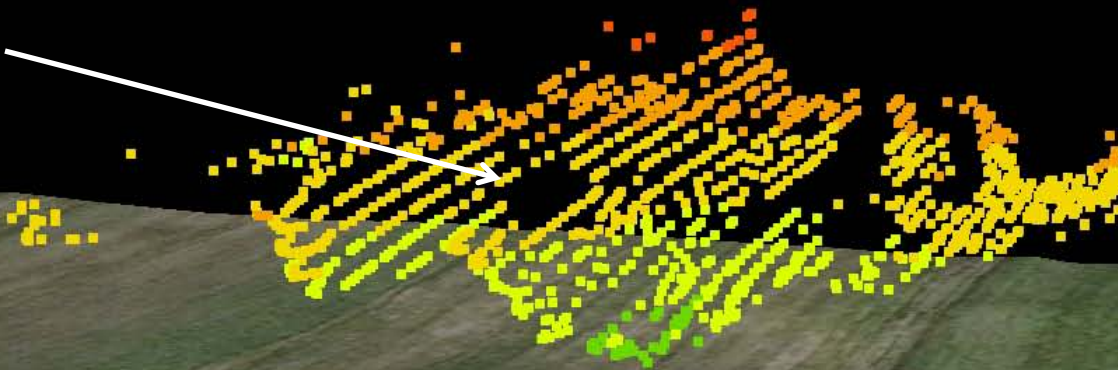
Point Cloud with 2008 Image on Topo - Something's Wrong!

Points are 30'
Too high.

- Although, the XY coordinates appear accurate:
- The Z values are 20 to 50 feet too high.
- The point cloud is tilted in 2 directions with a northwestward resultant.

- The control points used were well-spaced in the XY plane but not in Z .
- The Z points were at the edge of model space and disproportionately impacted the low-angle geometry causing rotation upward.
- A line of known length was not level and caused westward tilt.

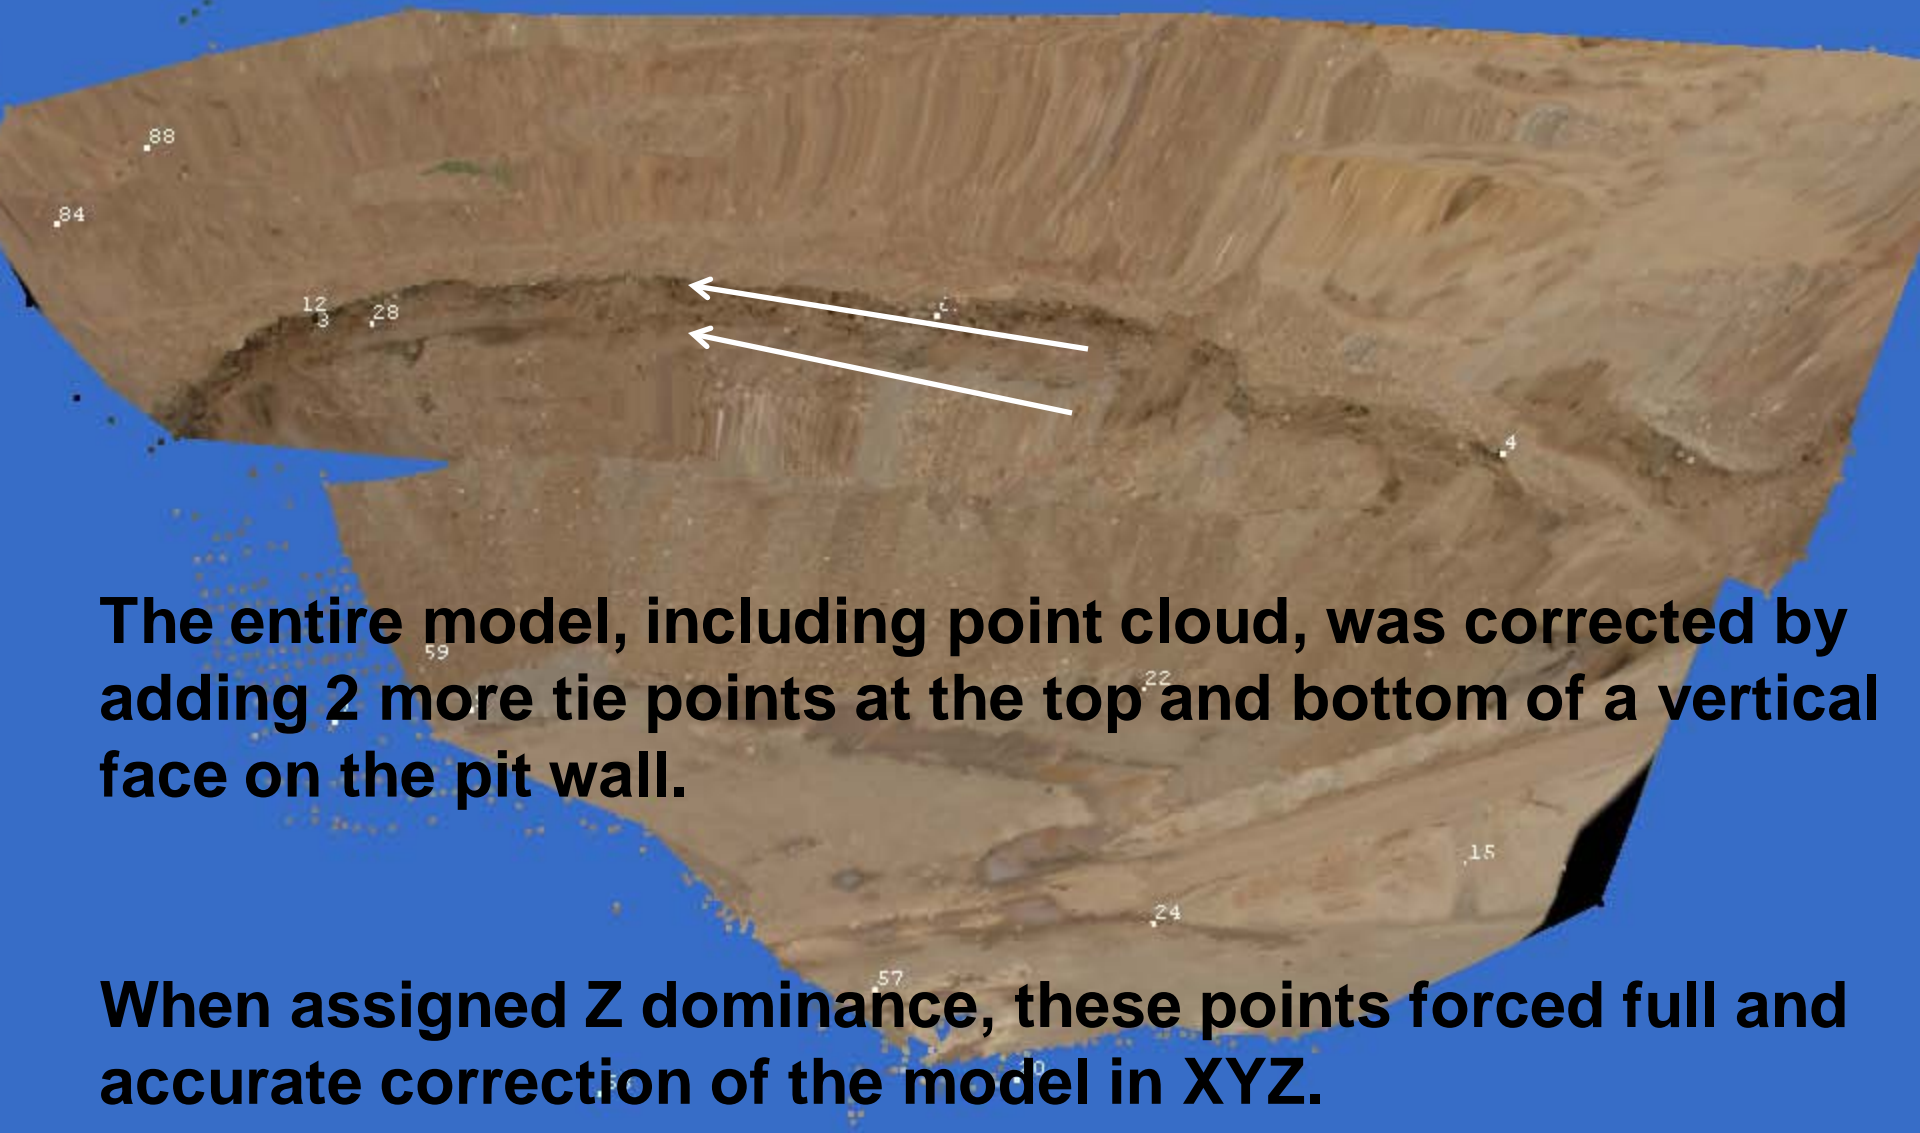
Correction was Trivial

The entire model, including point cloud, was corrected by adding 2 more tie points at the top and bottom of a vertical face on the pit wall.

When assigned Z dominance, these points forced full and accurate correction of the model in XYZ.

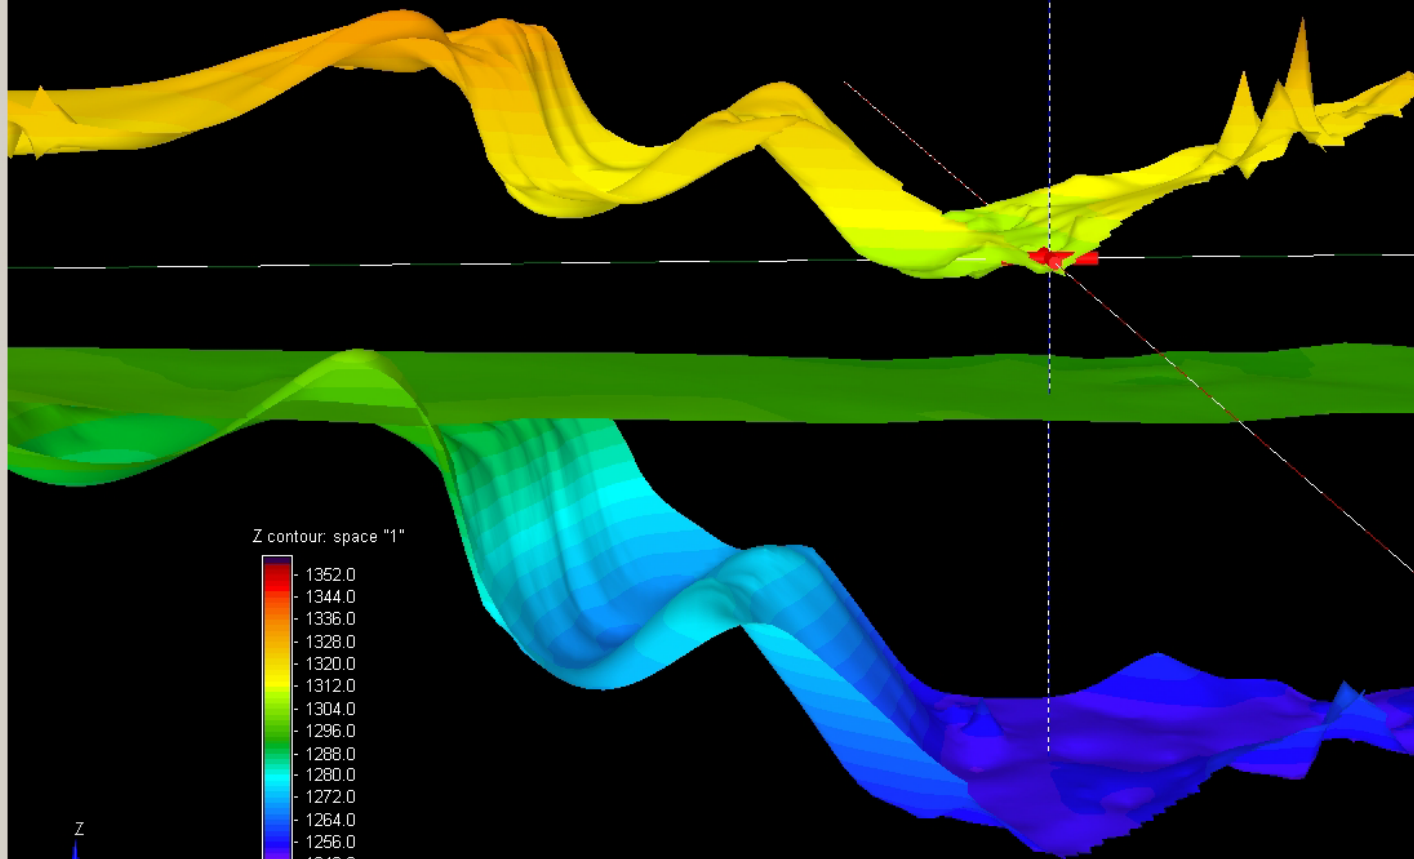
Before and After Correction

Original Ground Shown

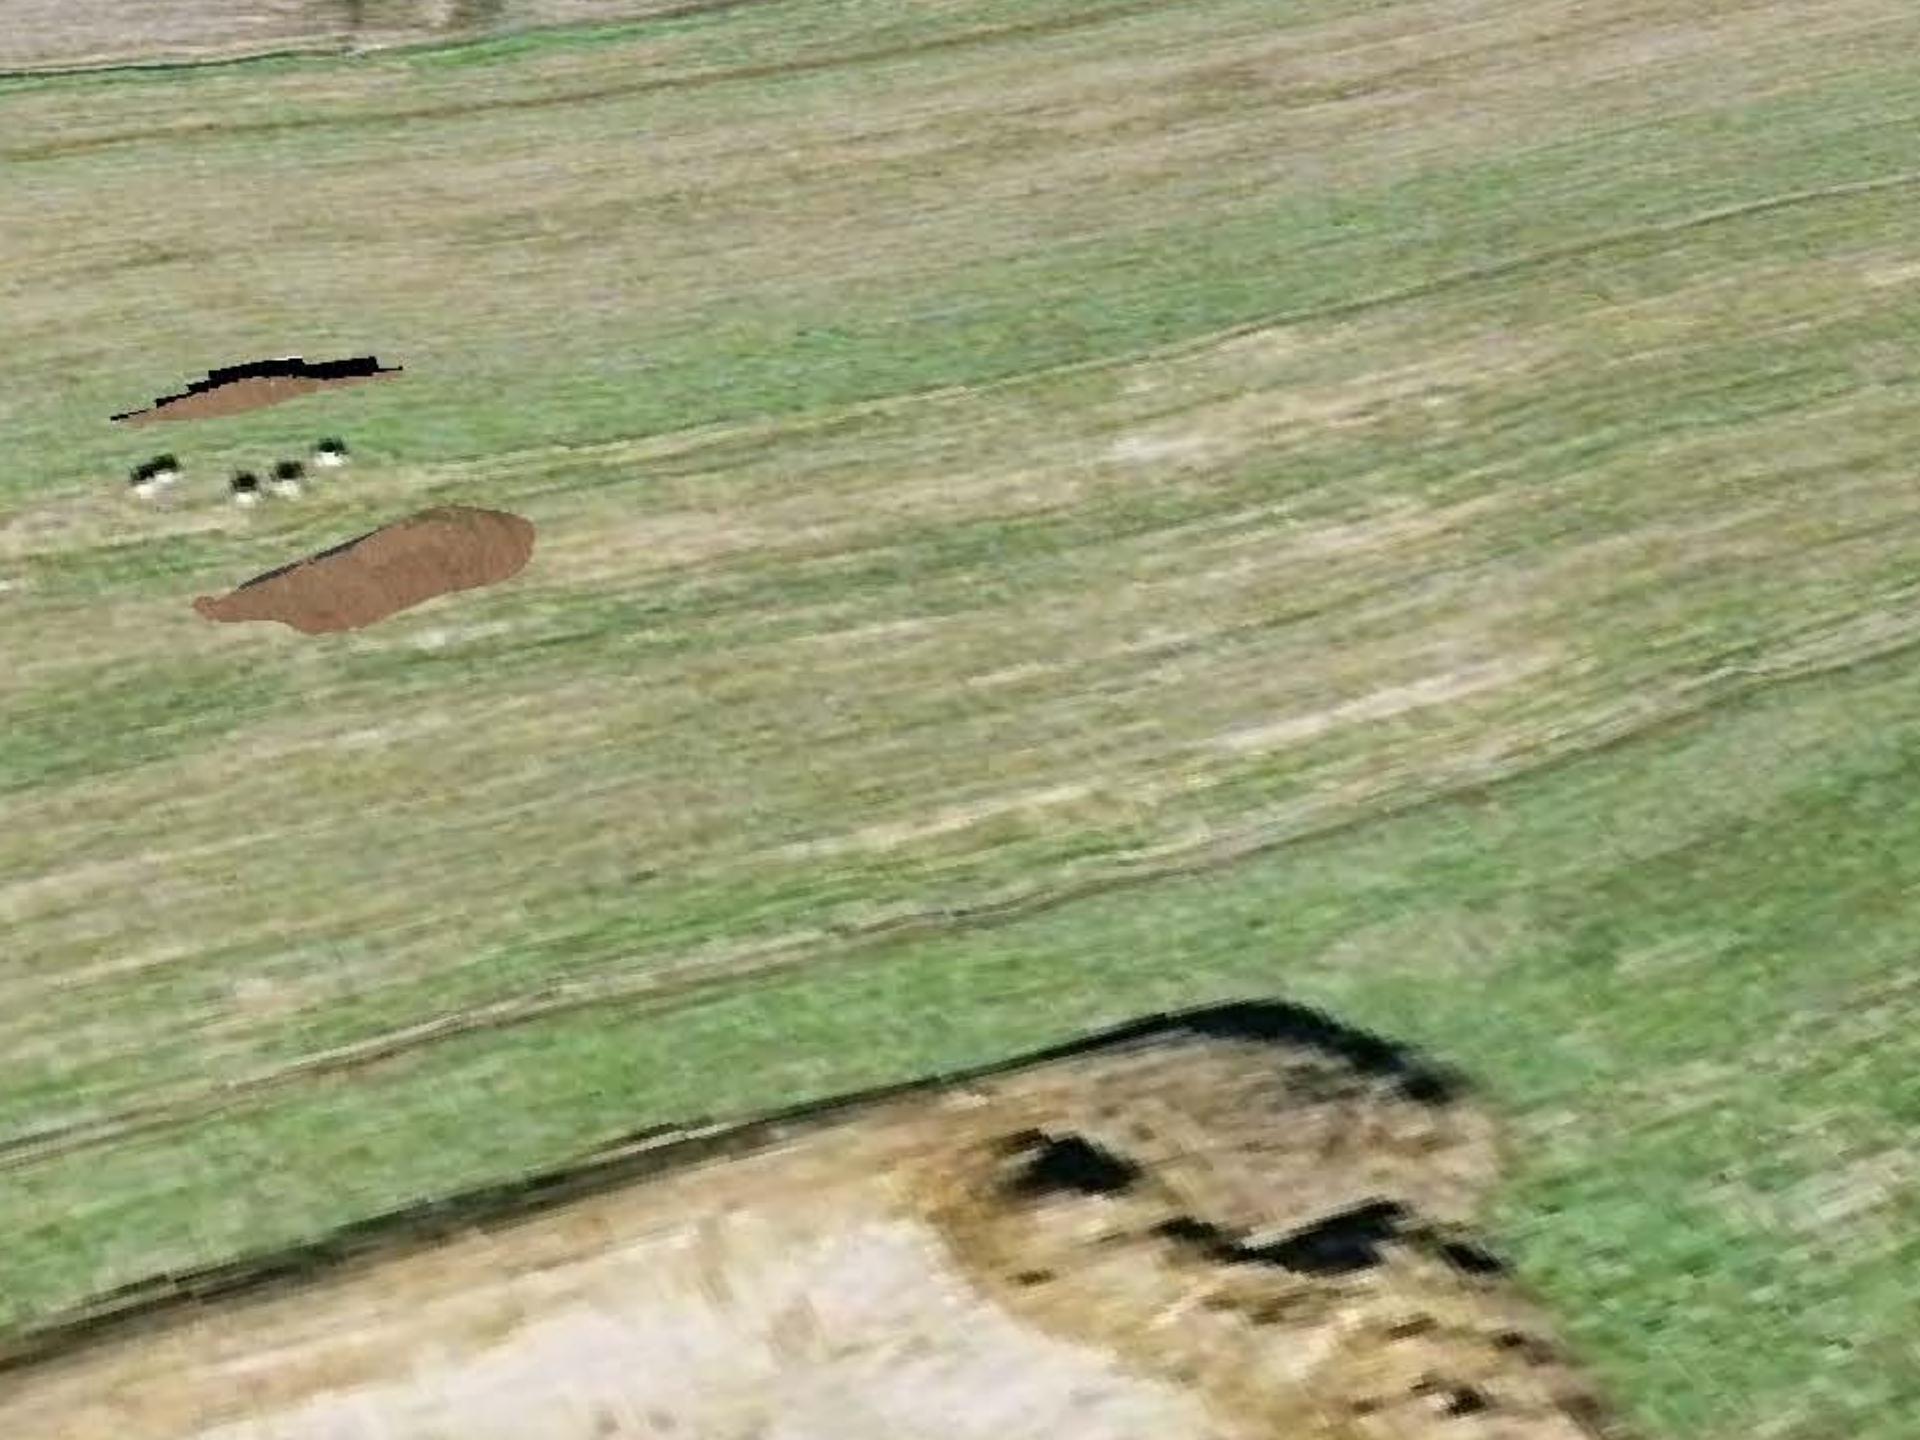
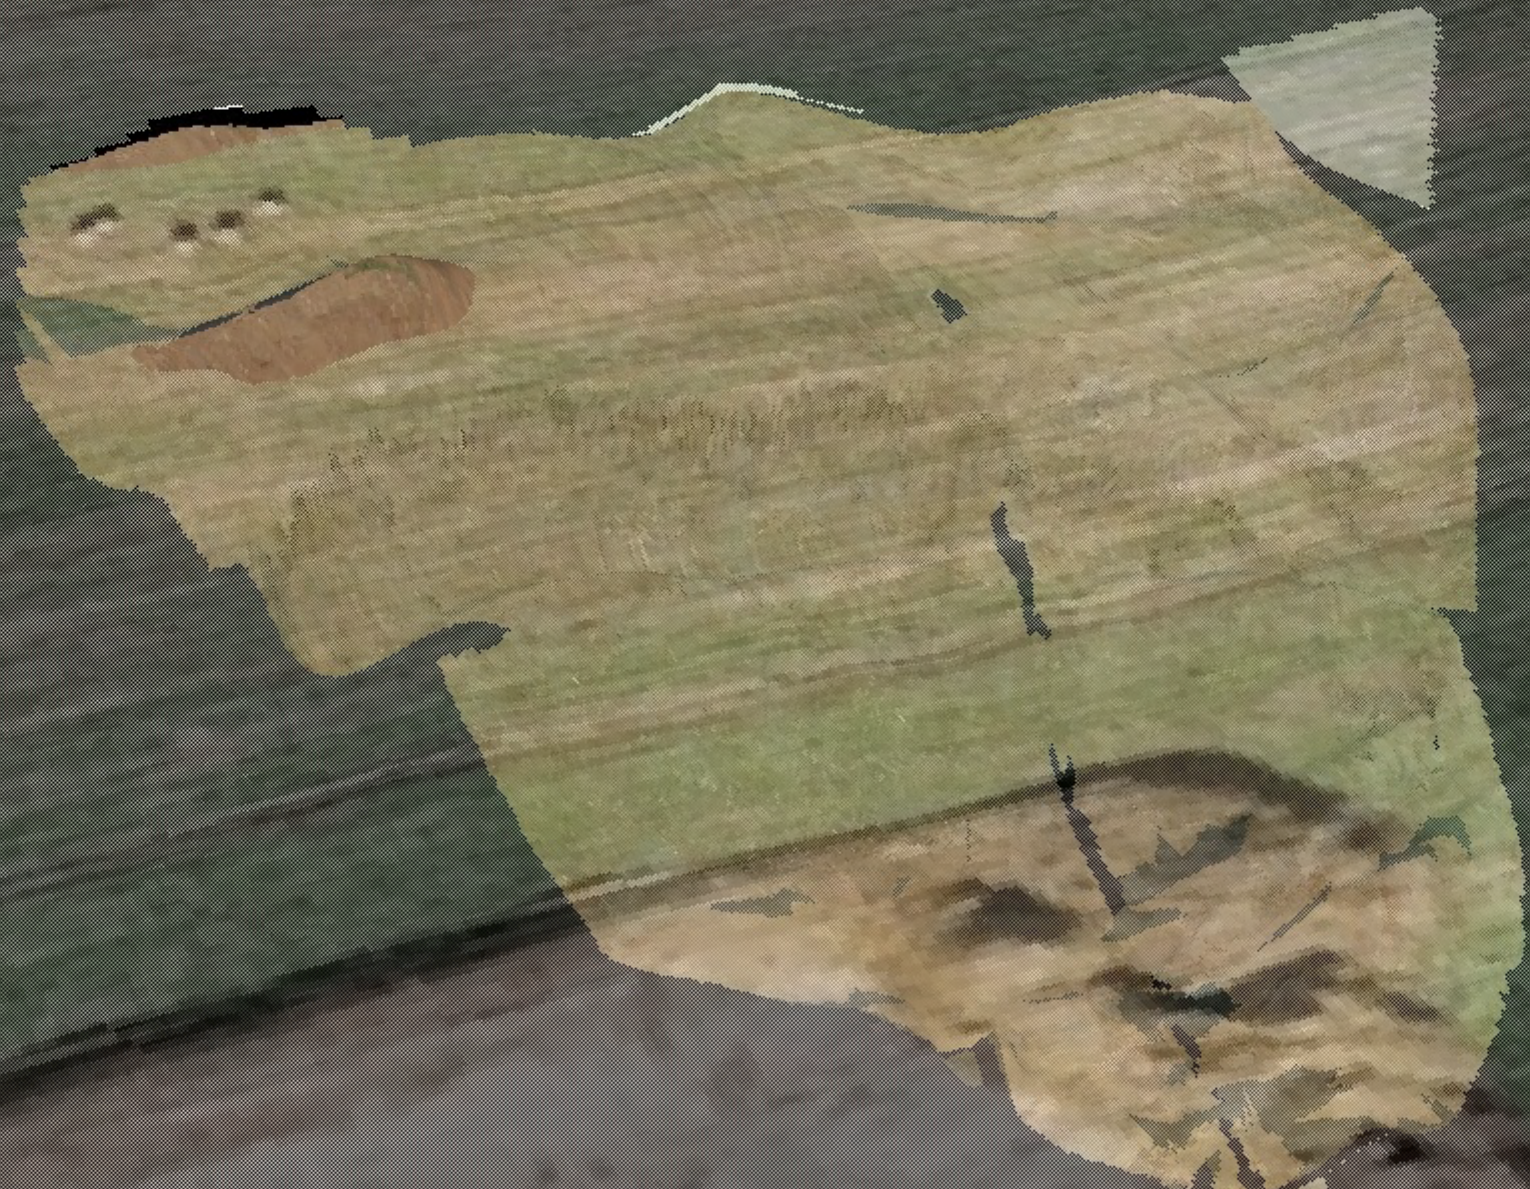
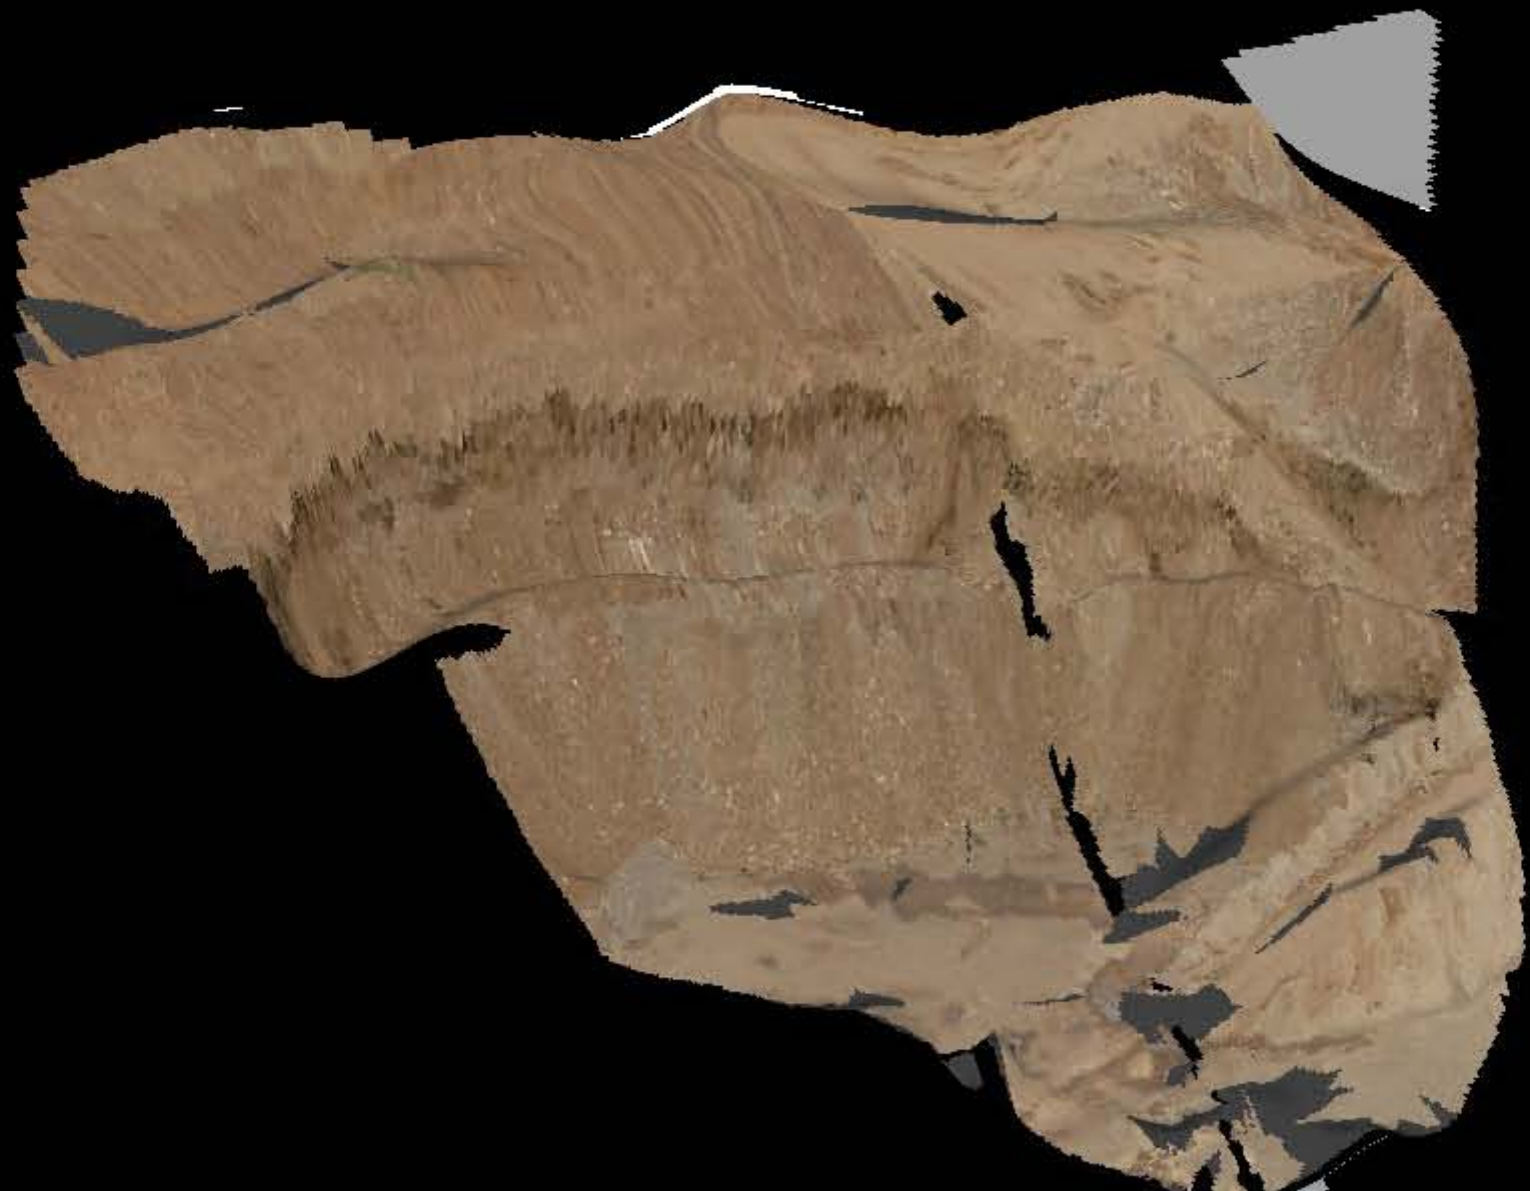
Putting the Pieces Together

- 2006 topography
- 2008 image showing start of pit
- 2009 partial pit model
