Accuracy of SUAS Photogrammetry for Use in Accident Scene Diagramming

Drew A. Jurkofsky
Unmanned Experts

CITATION: Jurkofsky, D., "Accuracy of SUAS Photogrammetry for Use in Accident Scene Diagramming," *SAE Int. J. Trans. Safety* 3(2):2015, doi:10.4271/2015-01-1426.

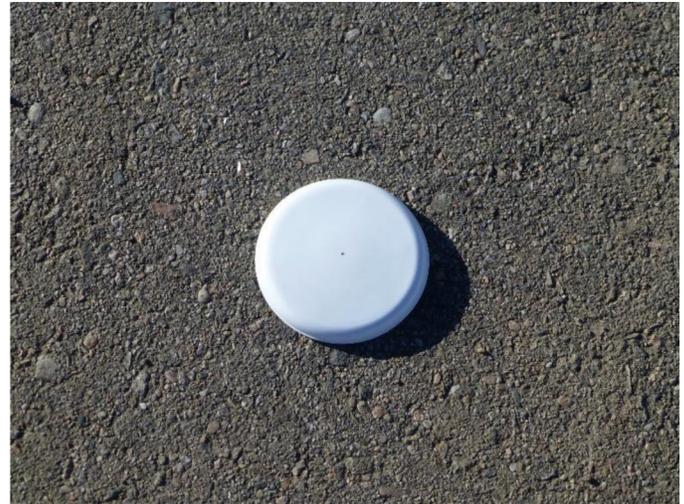
Figure 1. Circular plastic target with a dimple drilled in the center.

Circular white plastic targets were used to mark fixed objects and specific physical evidence in each accident scene for a quantitative comparison. The targets were 12 cm in diameter with a small dimple drilled in the center (Figure 1). The targets were fixed to the roadway using double-sided tape so they could not be easily moved. Targets were placed at all four corners of the test area for ground control and subsequent orientation of the photogrammetric measurements (Figure 2). The simulated light poles were placed at the corners of the accident scenes along the main road and were used as two of the ground control points.

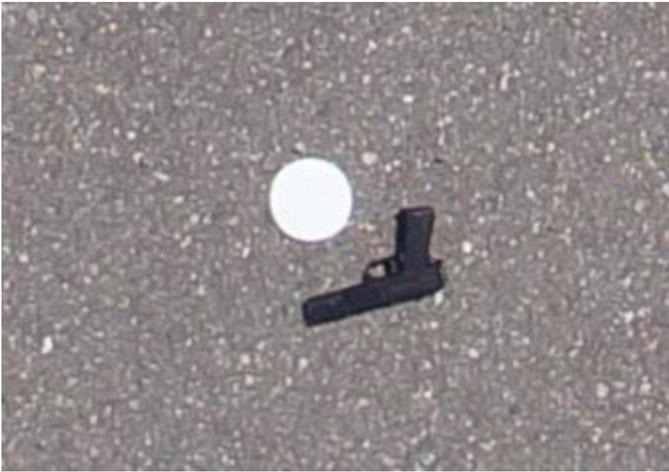
Figure 3. Image of a circular plastic target next to a handgun taken by a 24-megapixel camera at 20 meters flying height.

An assortment of items, each marked with a comparison target and used to simulate physical evidence, were included in each accident scene. The items were chosen to replicate evidence commonly seen in both accident and crime scenes. Items included a pen, shoes, clothing, handgun, cellphone, keys and coins. An upside down bucket with a circular target on top was added to determine the accuracy of the vertical or z-axis measurement. The purpose of the objects was to add realism to the scene, determine the resolution of individual items from the aerial imagery and add context to the circular targets (Figure 3).

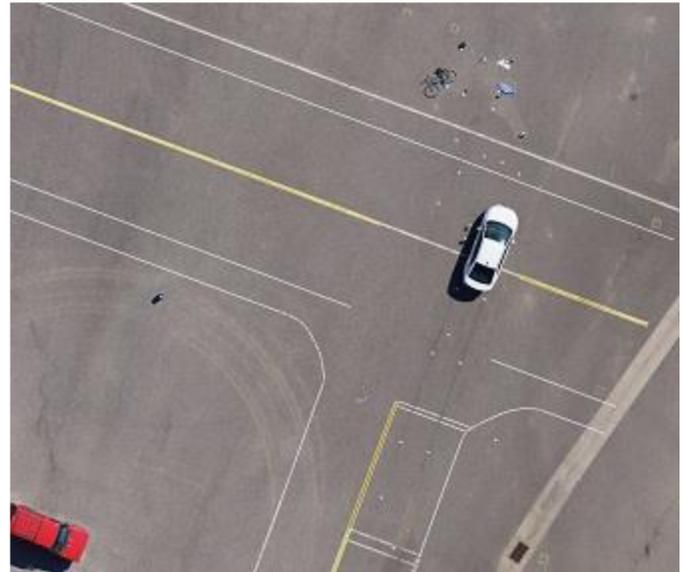
Figure 5. Car versus bicycle mock accident scene.

The second mock accident was between a Chevrolet Malibu and a bicycle. In the scenario, the Malibu was traveling on the secondary road and disregarded the stop sign at the main road. The bicycle was coming from the right of the sedan and traveling in the bicycle lane closest to the secondary road. The front of the Malibu contacted the left side of the bicycle and threw the bicycle in the direction of the sedan. The Malibu was skidded through the T-intersection to rest so

actual skid marks were present. There were 31 targets placed throughout the scene to mark ground control, physical evidence, the fixed objects and skid marks (Figure 5).

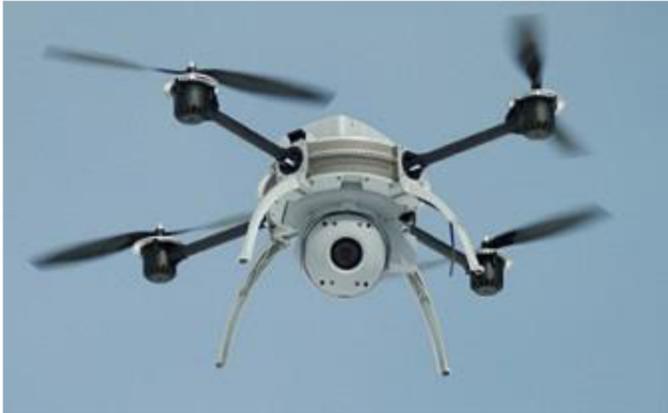
Figure 6. Aeryon Scout with 4-megapixel integrated, stabilized camera. Manufactured by Aeryon Labs, Inc.

low-resolution integrated camera and a high-resolution consumer grade camera. The Aeryon Scout, manufactured by Aeryon Labs, Inc., was powered by 4 rotors (Figure 6). It had an integrated, stabilized camera with a 4-megapixel resolution and 11.9 mm focal length. The DJI S800, manufactured by DJI, was powered by 6 rotors (Figure 7). It was equipped with a Zenmuse brushless gimbal and a Sony NEX-7 24-megapixel camera with a 24mm Zeiss lens.

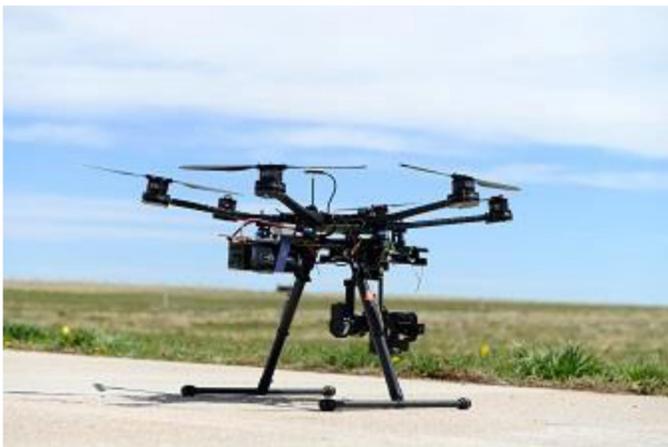
Figure 7. DJI S800 with Zenmuse brushless gimbal and Sony NEX-7 24-megapixel camera with 24 mm Zeiss lens. Manufactured by DJI.

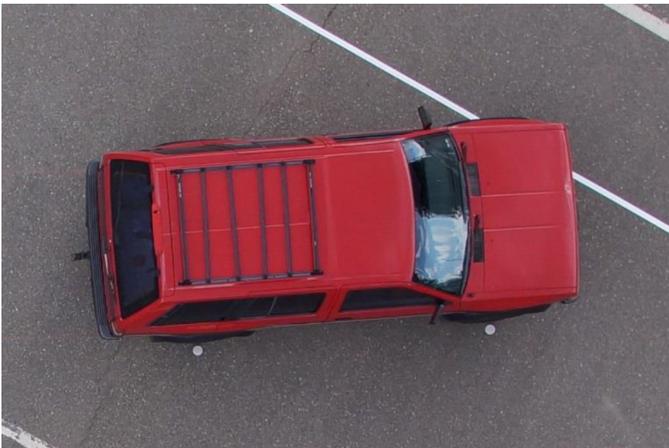
Figure 9. Circular markers used to mark vehicle rest location.

To measure the vehicle rest locations, markers were placed next to the vehicle wheels and centered at the hub (Figure 9). This was done for each flight mission except for the aerial imagery from the Aeryon Scout of the two vehicle accident.

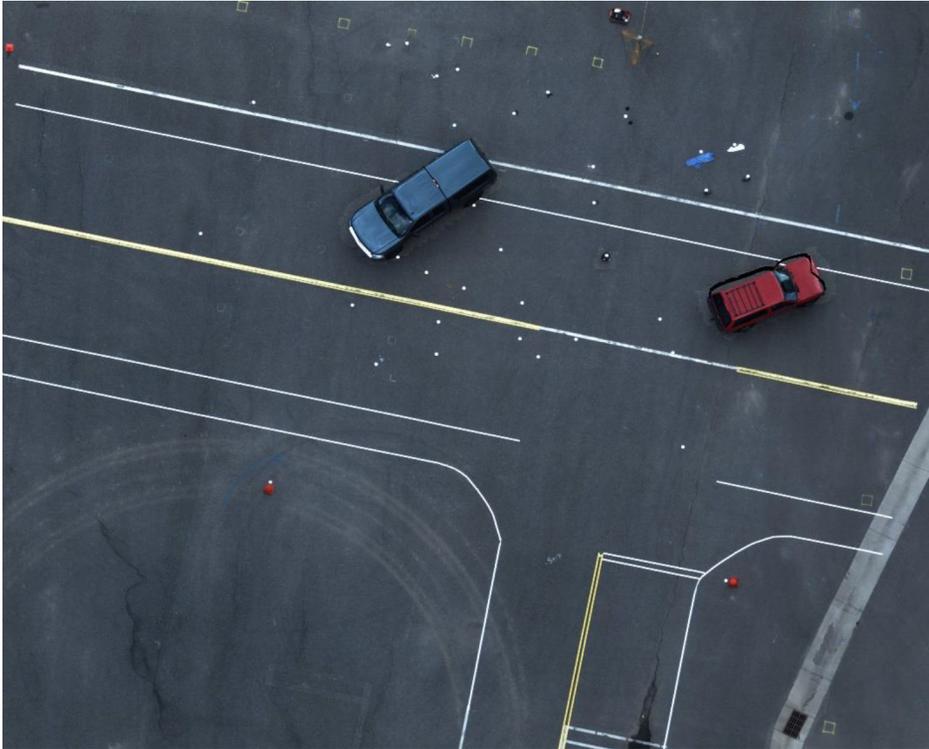
Figure C1. Two vehicle mock accident scene orthophoto from aerial images taken by a 4-megapixel integrated camera (Aeryon Scout).

Photogrammetric software allows for the creation of orthophotos where all of the individual images are stitched together to make a single orthomosaic. Like an aerial image from a manned aircraft, this can be used as a texture for a 3-dimensional model or for demonstrative purposes. Orthophotos from both mock accident scenes are shown in [Appendix C](#). Orthophotos from the two vehicle accident are shown in [Figures C1](#) and [C2](#). Orthophotos from the car versus bicycle accident are shown in [Figures C3](#) and [C4](#).
