PHOTOGRAMMETRY FOR THE PREPARATION OF ARCHAEOLOGICAL EXCAVATION. A 3D RESTITUTION ACCORDING TO MODERN AND ARCHIVE IMAGES OF BEAUFORT CASTLE LANDSCAPE (LEBANON)

Pierre Grussenmeyer ^a, Jean Yasmine ^b

CIPA Special Session
Low Cost Systems in Recording and Managing the Cultural Heritage

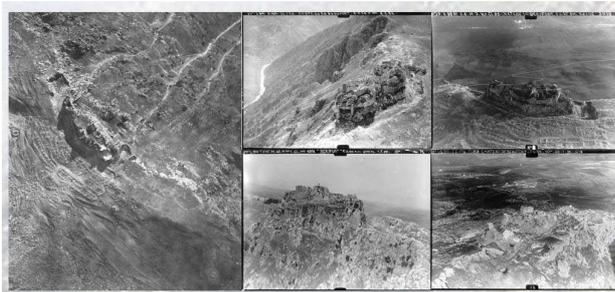
1930-1936: Archive images of the French Air Force of the Levant (aerial large format images)

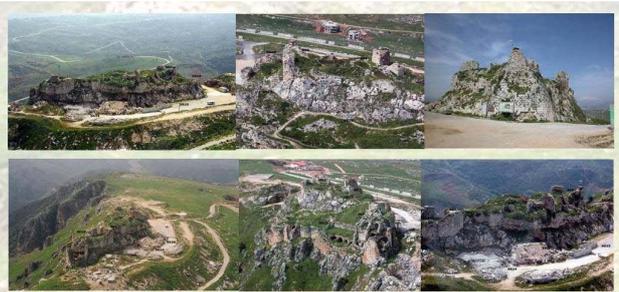
2003: Modern digital images (aerial and terrestrial small format images)

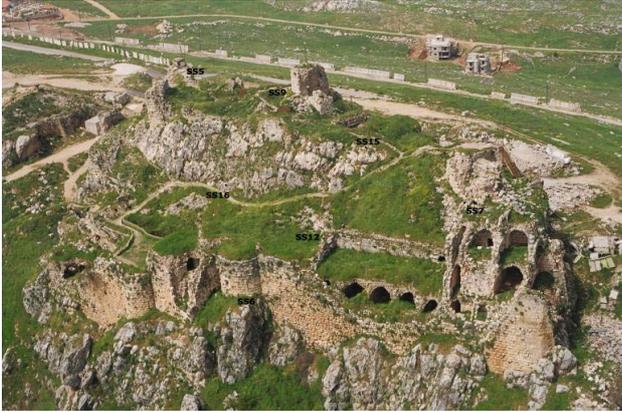
Figure 1. Recent aerial view of the Beaufort castle (Nikon F3, 2003)

After the end of the war, access to the castle became secure. There was a need to manage to realize a complete documentation of the unreachable parts of the castle (basically the eastern elevation over the valley). That's why a helicopter flight was scheduled in 2003. Aerial oblique views were taken (figure 1) in that flight. They were composed of digital images (Nikon Coolpix 5000, 2560x1920 pixels) and film-based small format color slides (Nikon F3, Nikkor lenses, 55 mm, scanned at a resolution of 3000x2000 pixels). Last but not least, a complete documentation requested terrestrial views of the castle; digital images and again film-based small format color slides were taken (figure 5). Thanks to this exhaustive documentation, three-dimensional restitution was possible. All the modern documentation was produced in one day.

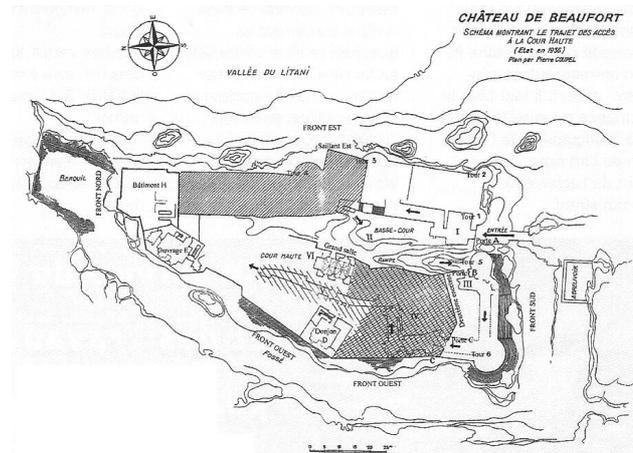
Figure 2. Map of Pierre Coupel (Architect) drawn up during the Deschamps survey (1936)

by the architect Pierre Coupel showing the means of access to upper courtyard of the castle (figure 2). After the independence of Lebanon in 1943, extensive works began.

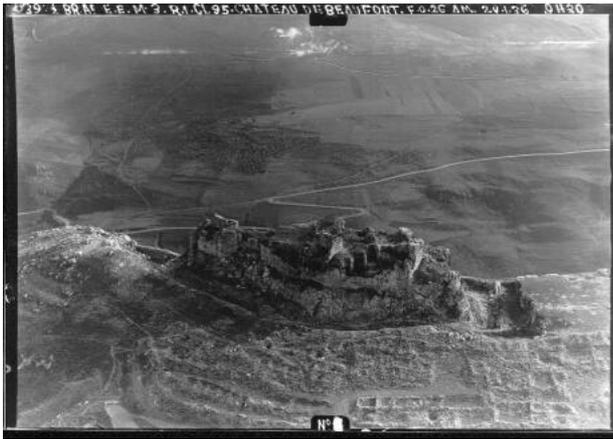
Figure 3. Example of archive photo of 1936 (IFPO), showing in the foreground the archeological hidden remains

b- Serie 2: These are photos still existing in the *Institut Français du Proche-Orient* (IFPO) archives (figure 3). All these photos were taken by the French air force of the *Levant* between the years 1930 and 1936. We were able to get duplicates (contact prints) of negatives at a size of 13cm x 18cm, scanned on a desktop scanner.

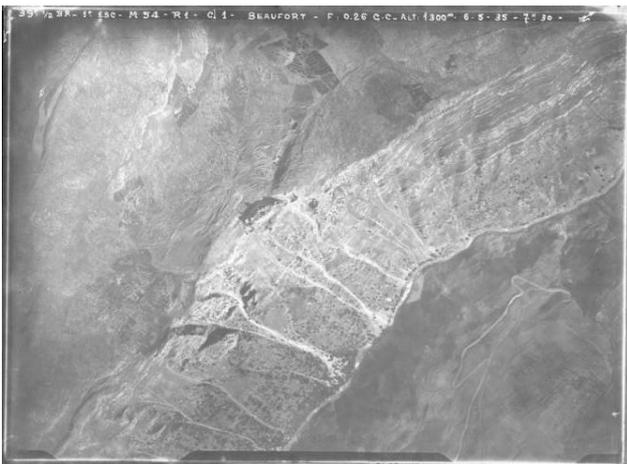
Figure 4. Example of archive photo of 1935 (DGA, area of Beaufort's castle), showing the castle (in the middle) and the landscape (focal length 26cm, flying height 1300m above ground, 2000m above sea level)

c- Serie 3: These are photos existing in the archives of the DGA. All these photos were taken by the French air force of the *Levant* between the years 1931 and 1936. They are vertical views (figure 4). Only contact prints at a size of 13cm x 18cm are available; the original negatives were not found. Those contact prints were scanned.

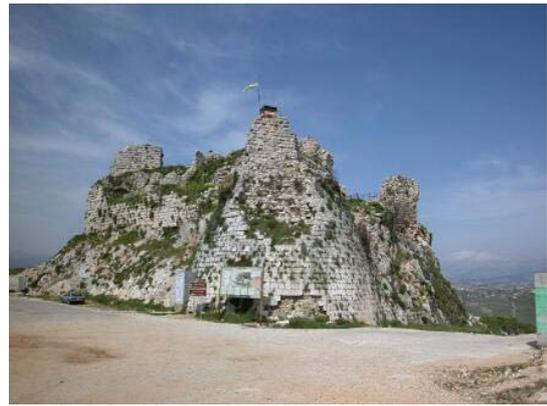
Figure 5. Recent terrestrial digital image (modern documentation, Nikon Coolpix 5000, 2003)

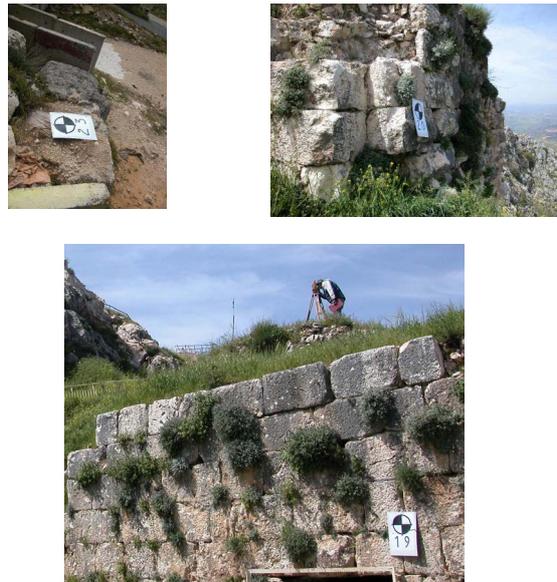
Figure 6. Examples of targets used for the control points

On that same day, while photos were being taken, a team of geodetic surveyors installed reference points on the ground and elevations of the castle. These points (figure 6) were easy to identify on the photos. A total-station was used by the surveyors to measure the reference points. This generated three-dimensional coordinates for these points.

More than 130 images were realized in spring 2003 with the Nikon F3 and Nikon Coolpix cameras (a hundred images on the ground and about thirty in the helicopter). A first block of 18 oblique views of the castle was oriented in June 2003 using the control points materialized on the ground by targets (figure 6). Standard deviations of about 10 cm on the co-ordinates of the points measured on the images have been obtained. We then selected in this project a set of points simultaneously visible on the images of 1931-1936, in order to define approximations of the photogrammetric parameters, and to calculate a block based on a selection of these archive images.

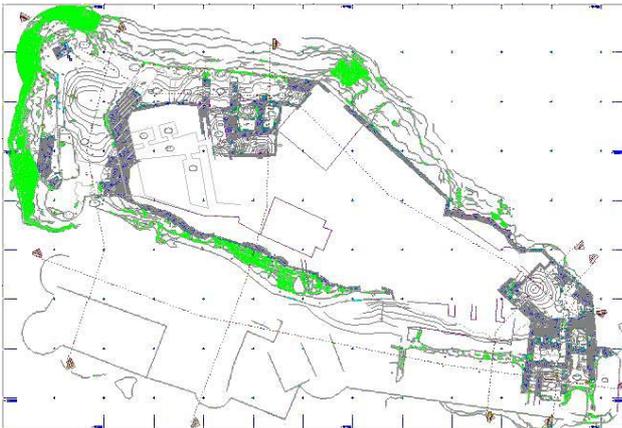
Figure 7. Example of 2D AutoCAD map from the tacheometric survey of 2002 (level 4 of the castle).

The first topographic surveys conducted during the preliminary study were not very accurate due to the difficulties encountered in trying to access some of the areas of the castle. These first surveys were performed using GPS and tacheometric techniques. The AutoCAD maps (figures 7 and 8) used to establish the tender documents for the restoration of the castle were based on these surveys. The inaccuracies of these surveys did not represent a major problem for the restoration of the visible areas of the castle. However, these inaccuracies prevented us from computing the exact position of the archaeological hidden remains. We plan to generate a new AutoCAD documentation showing the surroundings of the castle and the archaeological hidden remains that should be dug out (§5).

From the block of images previously oriented, the restitution initially carried out in 2D in Autocad (e.g. fig. 7 and 8) will be enriched by a 3D restitution corresponding to the objectives of the documentation. We are then able to calculate and draw the visible structures from the aerial and terrestrial photographs of 2003 by digitalizing on the images. One will proceed in an identical way on the archive photographs to measure the archaeological structures currently covered by the remains of the war currently embanked or destroyed (fig. 10), or to plot in 3D parts of the castle (see §6).

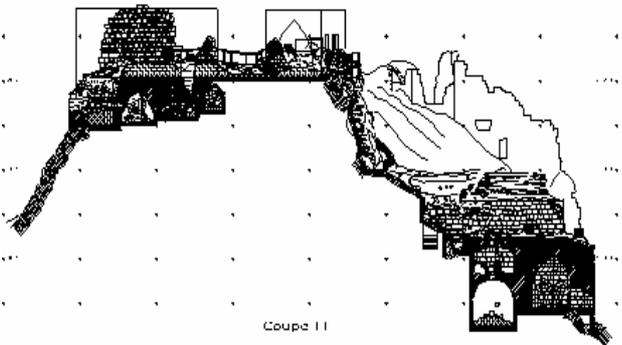
Figure 8. Example of 2D AutoCAD section.

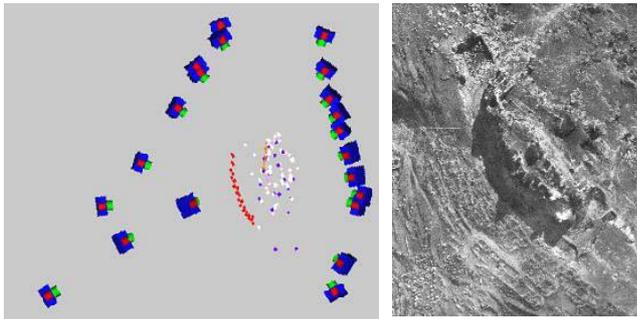
Figure 9. Overview of the camera stations and the block configuration after the exterior orientation. At the right: a vertical view of 1935 allowing the location of the camera stations.

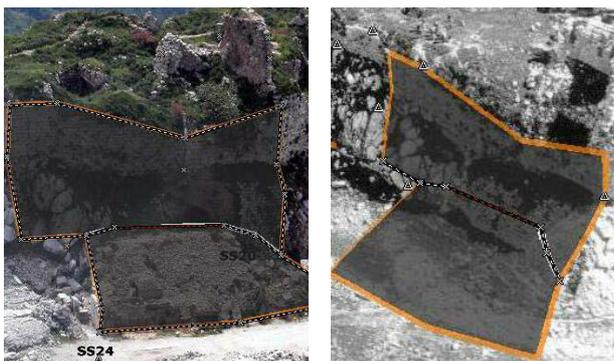
Figure 10. Restitution of the embankment areas: on the left, the boundary of the embankment is marked on a photo of 2003 and on the right, the corresponding surface is projected on an archive photo of 1936

The superposition of the two restitutions makes it possible to highlight the areas of interest (figures 10 and 11) for archaeological work and to estimate work of civil engineering (fill, cubature, rebuilding, etc).

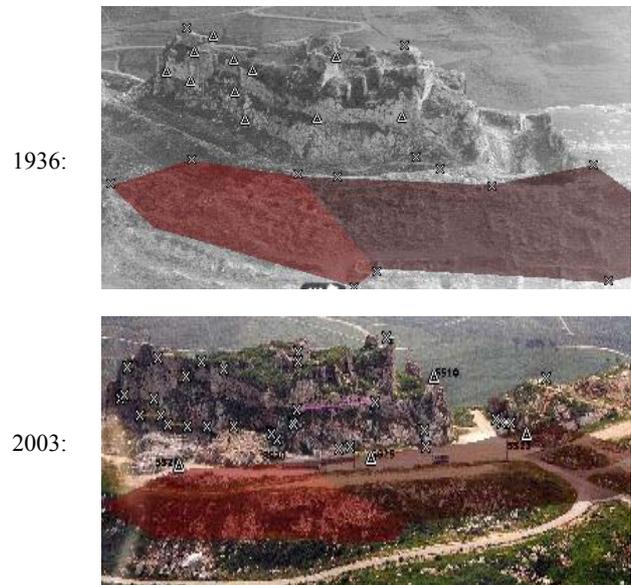
Figure 11. Archaeological structures are measured on the archive images of 1936 and the corresponding surface is shown on the photos of 2003

either from the images of 1936, or of those of 2003. From the resulting 3D photomodels, orthophotos can be calculated for the two periods, as e.g. for the frontages of the castle or the installations around the site covering the archaeological structures (fig. 11).

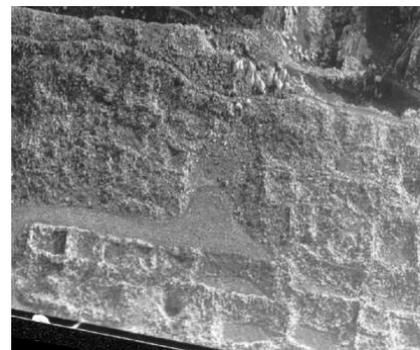
Figure 12. Example of orthophoto of the archaeological structure (computed from an archive image of 1936).

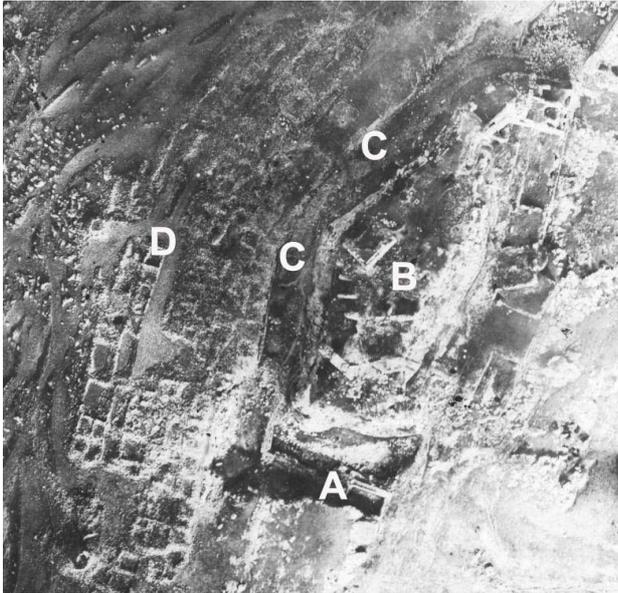
Figure 13. Vertical archive view showing some studied parts

The study is currently focused on different parts of the castle (figure 13). For some of them (as courses of bricks or stoneworks "label B"), a 3D restitution of both archive and recent images is possible.

Parts recovered by embankment are modelled from only archive images (watering place "label A", counterscarp "label C" and archaeological remains on the western part of the castle "label D").

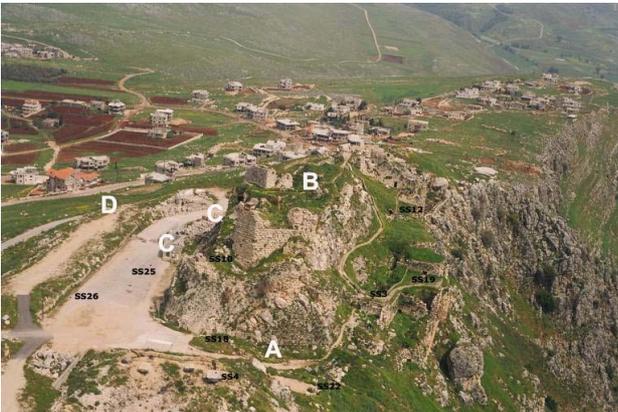
Figure 14. Recent image showing the surroundings of the castle and the current constructions
